Voice of America Mall Target Project: A Steel Push Pier Underpinning Case Study

by Howard Perko, Bill Bonekemper, Dave Jacob and Brian Dwyer
Magnum Piering, Inc., West Chester, Ohio

March 18, 2003

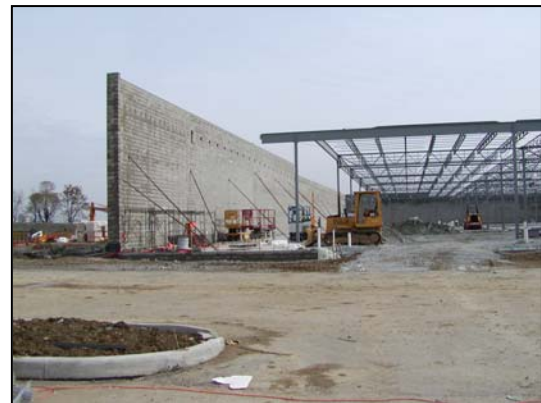
The first wall that the owner, the construction manager, and Dwyer's Dave Jacob visited was the north wall – the wall with the most severe problem. A considerable crack in the interior concrete slab was immediately apparent, and it measured approximately 1/2" to 5/8" wide at its worst point. The crack ran adjacent to the wall for approximately 200 feet and ranged in distance from 3 to 4 feet from the wall's base. The two men quickly pointed to some hand written measurements marked at eye level on the wall about every 20 feet. As they explained to Dave, these markings represented the distance the north wall had rolled outward (to the north) at the top of its 27 foot height as measured by the steel contractor on October 10th. The measurements ranged from a minimum of 1/8", close to both the west and east corners of the wall, to a maximum of 2-3/4", near the center of the wall's 310-foot total length.

Fig. 1 North Wall of Target Store Under Construction

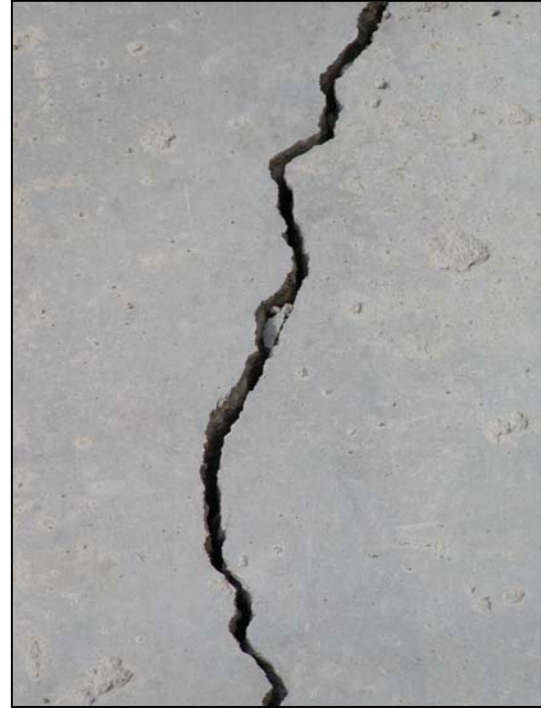
Fig. 4 Close-up View of Example Floor Slab Crack

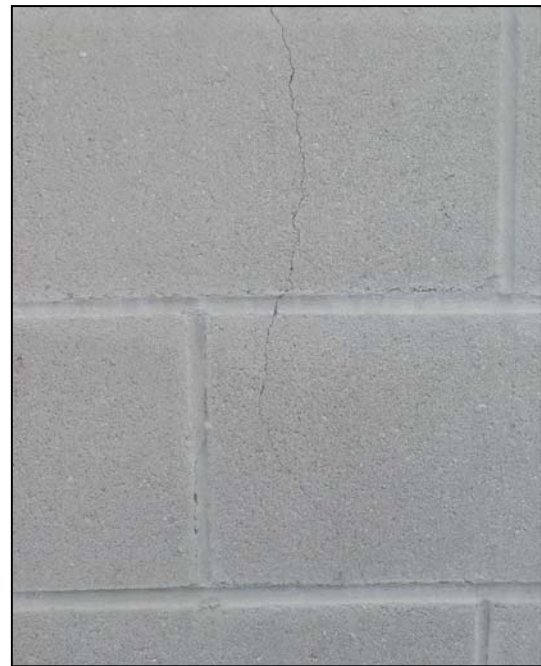
When the three men finished discussing the conditions at the north wall, they quickly went to examine the similar conditions at the structure's south wall. Although the settlement and subsequent outward roll of the south wall was not as severe as with the north wall, the top of the south wall had rolled outward (south) 1-7/8" inches near the center of the wall's 260 foot total length, as recorded by the steel contractor. The concrete slab also had a crack similar to the crack at the base of the north wall. The slab crack is shown in Figs. 3 and 4. A similar foundation design change had been made on this side of the building due to the close proximity of the property boundary. The foundation failure of the south wall was again attributed to the eccentric loading on the spread footing for the first approximately 200 feet of the wall measuring west to east. A photograph of one of the cracks in the CMU block wall is shown in Fig. 5.

Fig. 5 Example Vertical Crack in South Wall of Target Store

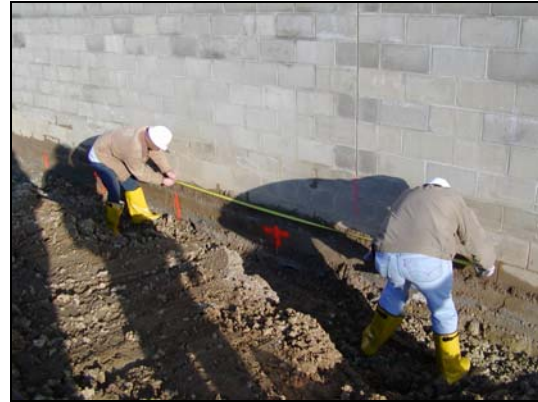
Fig. 9 Marking Bracket Positions Along Foundation Walls

Next, bracket positions were marked along the wall, as shown in Fig. 9. Each Magnum Piering bracket was secured using $\frac{1}{2}$ inch diameter by $5\frac{1}{2}$ inch long, wedge anchors extending into the side of the footing. Normally, the footing is chipped flush with the foundation wall prior to bracket installation in order to minimize

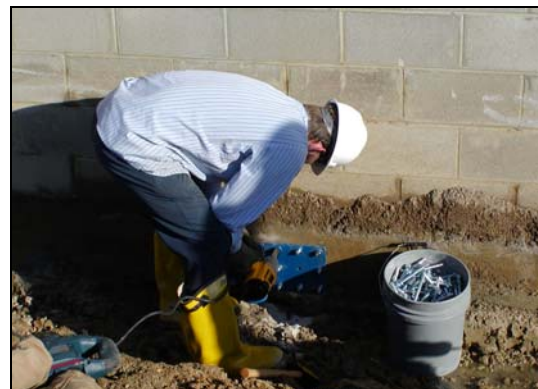
Fig. 10 Bracket Installation

rotational eccentricities. This step could be skipped, since the footing was already flush with the wall above. Bracket installation is shown in Fig. 10.

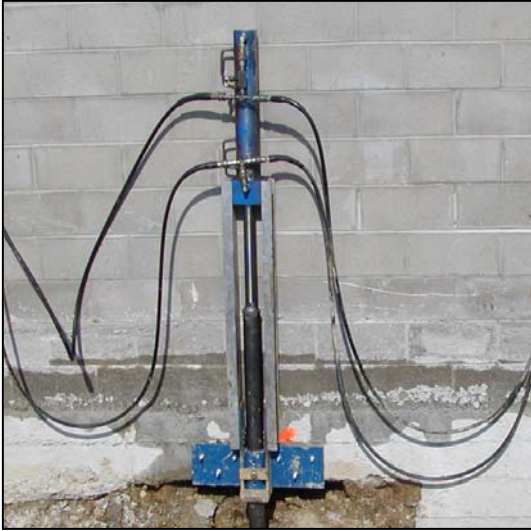
Fig. 11 Pier Installation

Next, the ram assembly is attached to the bracket and the installation of 30 inch sections of 3 inch O.D. high strength steel pier shaft is conducted, as shown in Fig. 11.

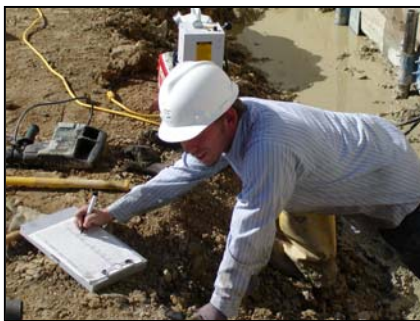
Fig. 12 Logging Pier Depth and Hydraulic Pressure

Hydraulic pressure during pier installation is recorded at various depths, as shown in Fig. 12. A log of these readings is prepared for each pier location. Pier installation is halted once the hydraulic pressure corresponding to the design ultimate capacity of the pier is reached. At that point, the load is maintained on the pier and movement is monitored over a period of time until the pier movement decreases to less than 1/16th inch per ½ hour. This process constitutes a full-scale load test at each pier location.

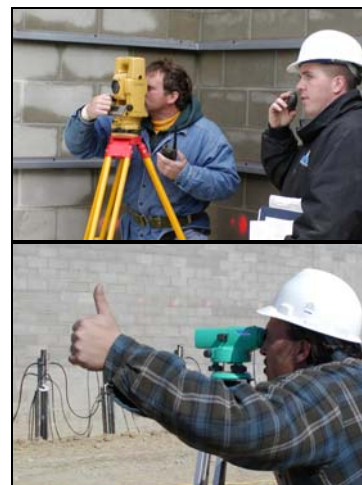
Fig. 13 Monitoring Wall Movement During Lifting Phase

Survey stations were established inside and outside the building in order to monitor movement, as shown in Fig. 13.

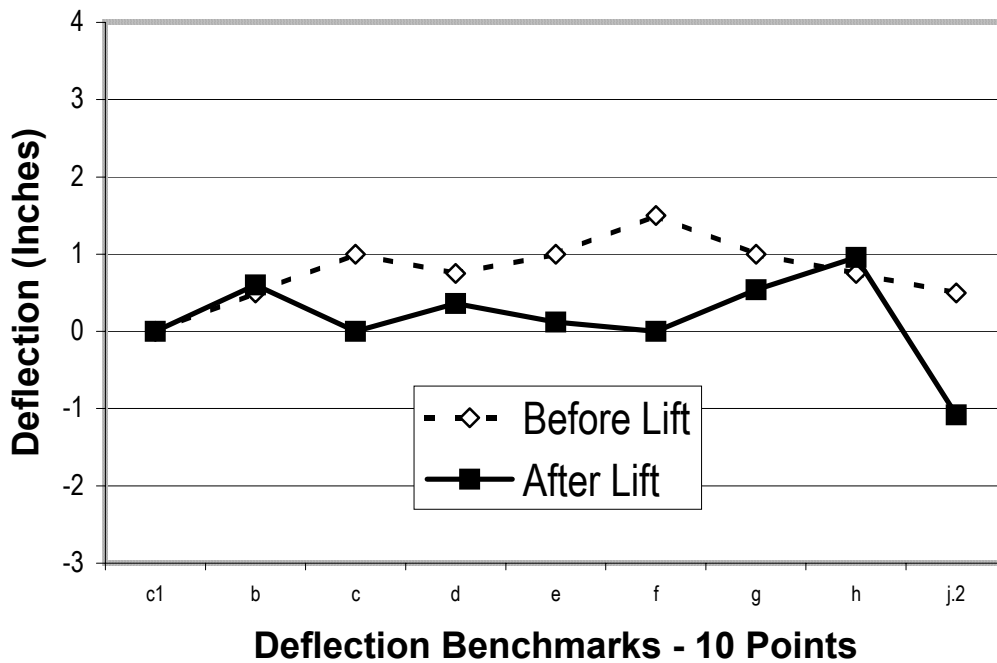
Fig. 17 Initial and Final South Wall Top Location

Both walls were successfully relocated. Initial and final top of wall locations with respect to plumb are shown in Figs. 16 and 17. The North and South walls were restored to within ½ inch of plumb, except for the Eastern portion of the South wall. The reason for this discrepancy is that the wall was not constructed perfectly straight. It was identified during this phase that the South wall had started to settle during masonry construction, and the block mason had to adjust the course of the wall. Afterward, the wall continued to move and eventually ended in the position where Dwyer was called to the site. The wall could not be improved beyond that shown unless it was reconstructed. It was deemed that the lift was acceptable and the underpinning project was completed.
