Concrete Lifting

CASE HISTORY

Royal Saint Georges
Fords Colony Williamsburg, VA

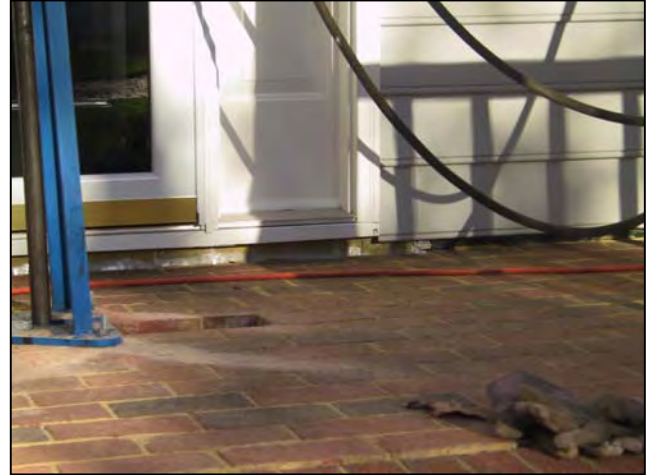
A residential custom home front porch slab overlaid brick paving system had settlement of up to 1 ½ “ due to the compression of sub-soils. Also, the interior crawl space and exterior porch foundation wall had settlement and distress.

The foundation was stabilized with Magnum 3” steel piers with heavy-duty Magnum angle brackets. Three total piers were required.

The installation of Magnum slab piers 5’ on center were utilized to transfer slab loads to proper subsoils.

Slab Jacking - After the piers were in place, 81 cubic feet of cementitious grout was injected into the void. Grout was injected between the slab and sub soils to consolidate the soil, fill the voids and support the slab/paver system. A total of five working days were required to make repairs.

The paving system settlement was corrected up to 1 ½” of lift, which returned the paving system to its original elevation. The above methods of repairs were less destructive and saved thousands of dollars over typical removal and replacement methods. Upon completion of this project, the owners contracted with Advanced Builders to complete masonry repairs and restoration.
