Failures of Helical Pile and Helical Anchor Projects and Associated Lessons Learned

Howard A. Perko, Ph.D., PE
Magnum Geo-Solutions, LLC

- I. Buckled Underpinning in New York
(a case for lateral bracing)
- II. Stadium Soil Nail Wall Failure
(a review of common anchor design mistakes)
- III. Out-of-Spec Sea Wall Anchors
(the importance of torque calibration)
- IV. Down-Drag of Grouted Helical Piles
(failure to account for consolidation)
- V. Settlement of Apartment Buildings
(redesign based on load tests)
- VI. Scaffold Collapse on Helical Piles
(death as a result of instability)
- VII. Collapse During Foundation Repair
(death as a result of undermining)

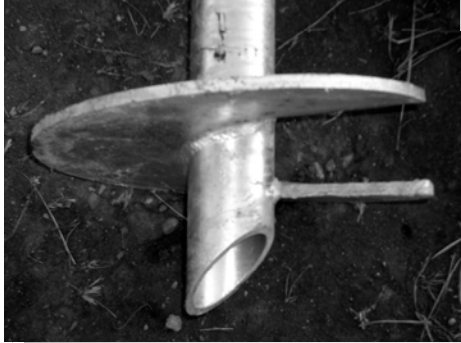
Conforming Helix

- 3" Pitch
- Parallel Leading & Trailing Edges
- Perpendicular
- Uniform Pitch
- Sharpened Cutting Edge

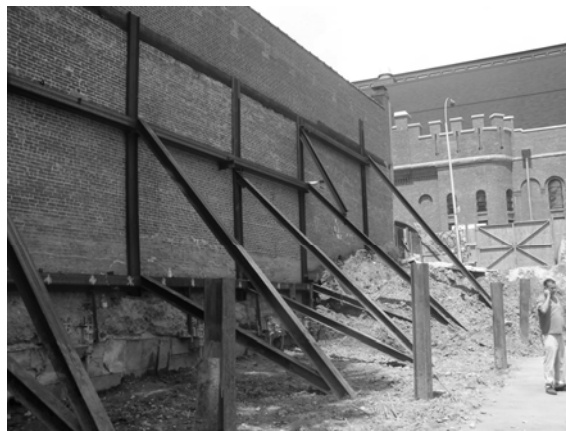
Buckled Underpinning in New York

- Helical piles were installed to reduce settlement during conventional concrete underpinning
- Footing rotated, piles buckled, and building settled severely
- Photo shows supplemental raker bracing system installed with deadmen after settlement

- Failed to brace the tops of piles

Per IBC2006: 1807.2.4 Pile or Pier Stability

- All piles shall be braced for lateral stability
- Three or more piles per cap is considered braced
- Piles staggered under a wall are considered braced
- Otherwise provide engineered means of lateral bracing

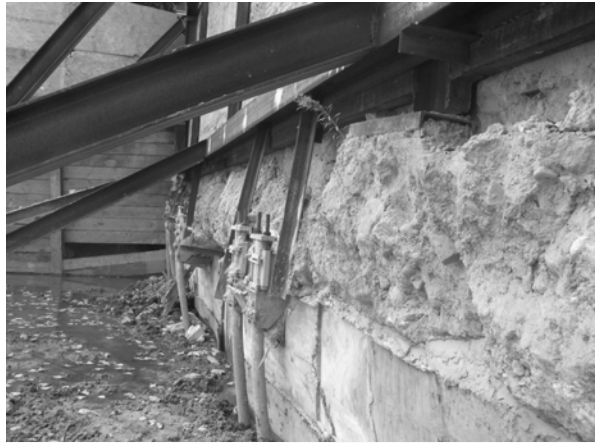
- Photo shows buckled pile and bracket system
- Helical piles were 1-3/4" square shaft with reinforcing sleeves
- All piles were installed along the outside of the building
- This and a similar failure were catalysts to a nearly 2 yr moratorium on helical piles in NYC

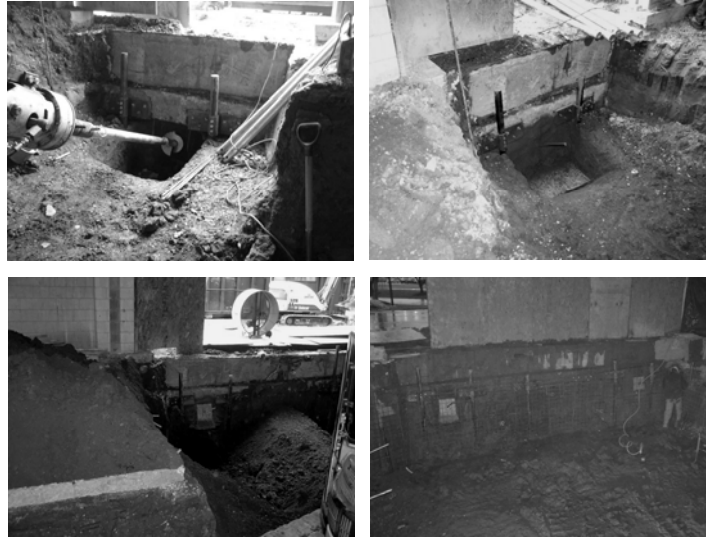
- Another solution is to install tie-back anchors to brace the foundation at the top of the piles.

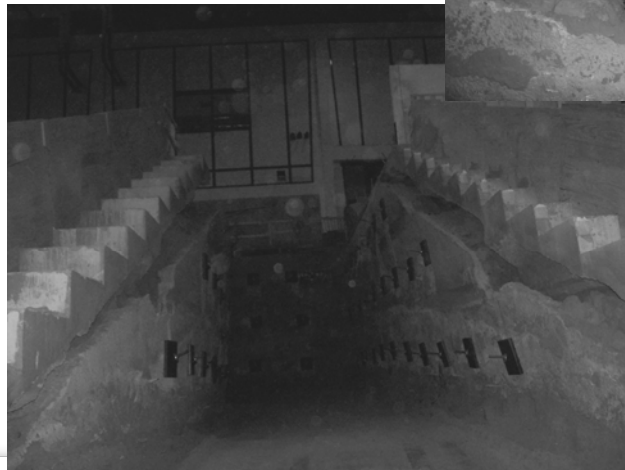
Stadium Soil Nail Wall Failure

- 3 rows of helical soil nails
- Approximately 15-foot cut between bleachers
- Reportedly a progressive failure

- Soil nails lacked continuous bonding
- Soil nail spacing too far apart
- Soil nail length too short
- Bearing capacity failure
- Insufficient lapping of reinforcing steel
- Poor drainage

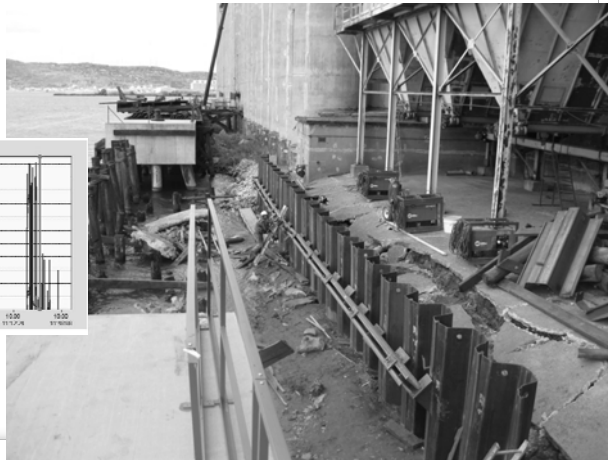
Out-of-Spec Sea Wall Anchors

- 1 row of approximately 35' long helical tie-backs
- Continuous torque readings during installation
- Approximately 15-foot cut to removed failed timber crib wall
- All 18 helical anchors failed proof test
- Supplemental anchors based on same design methods, installed by same crew using different torque motor passed proof tests

- Flawed torque motor calibration

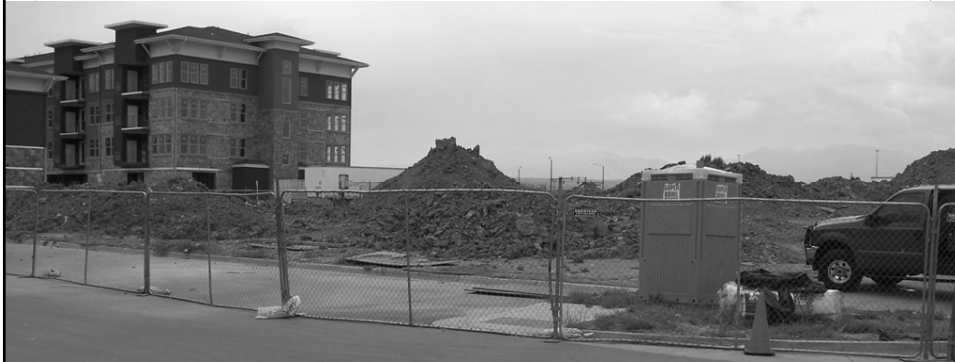
Settlement of Apartment Buildings

- Approximately 140 helical piles installed to support several 5-story apartment buildings
- Design load of helical piles= 90 to 130 kip
- Immediately after construction, several of the buildings exhibited settlement on the order of 4"
- Three of the buildings had to be demolished and re-built. The others were repaired by underpinning.

- Non-conforming helix invalidates capacity to torque readings
- Insufficient bearing area; relied on torque alone and did not check theoretical bearing capacity
- Over-reliance on load tests

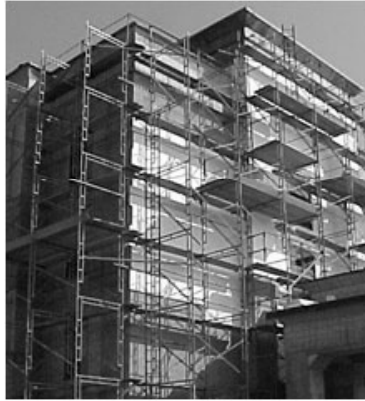
- Example Frame Scaffolding
(Note: This is not the actual scaffold that collapsed. Due to confidentiality, actual scaffold cannot be shown.)

- Approximately 4-story tall, temporary, stand-alone scaffold towers were erected to construct an elevated concrete walkway
- Each scaffold tower was supported on 8 helical piles
- During concrete placement, scaffold gave-way killing one worker and injuring 18 others

- Structural issues associated with scaffold design
- Lack of lateral stability
- No lateral capacity specification for the piles
- Square-shaft helical piles have negligible lateral capacity

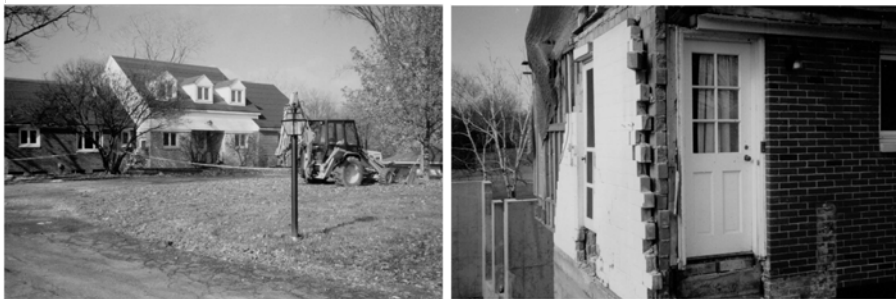
- An addition was being constructed on the back of this home
- The existing back wall experienced settlement
- A foundation repair contractor was called out to install several piles along the back wall

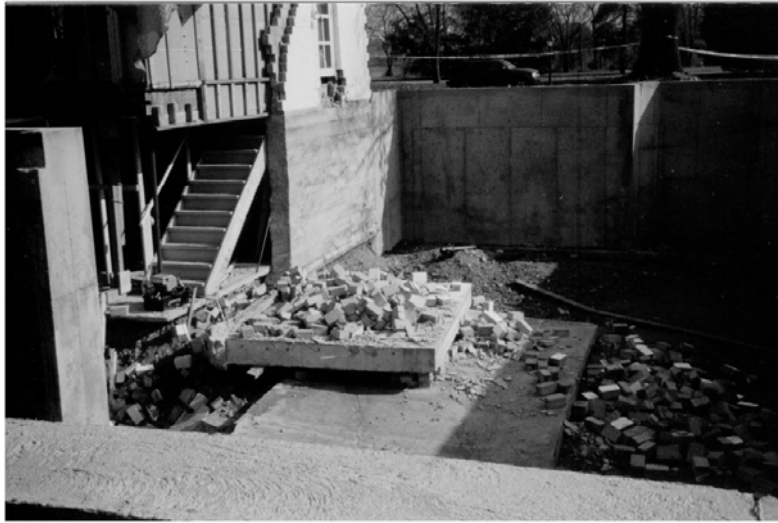
Collapse During Foundation Repair

- During installation of piers, the wall suddenly collapsed, tragically killing one of the workers.
