Failures of Helical Piles and Helical Anchors and Associated Lessons Learned

Author: Howard Perko, Ph.D., PE, Director of Engineering, Magnum Piering, Inc., Cincinnati, OH, USA

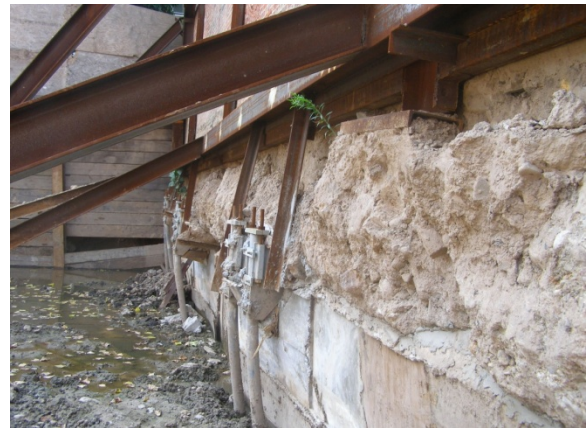
In early 2008, helical piles failed during excavation along a building in New York City. The “rubble” footing rotated, the piles buckled, and the building settled severely. A supplemental waler and raker bracing system was installed with deadmen piles to arrest building movement.

Failure of Unbraced Helical Piles in New York City (Courtesy of NYC Department of Buildings, Office of Technical Certification and Research)

The failure of helical piles in New York City can be explained by the lack of lateral bracing. Section 1808.2.9 of the 2008 New York City Building Code and the same section of the 2006 International Building Code state that all piles shall be laterally braced. The section goes on to state that bracing can be achieved by

alternating the location of piles on either side of walls, using a minimum of three piles under isolated columns, and other means.

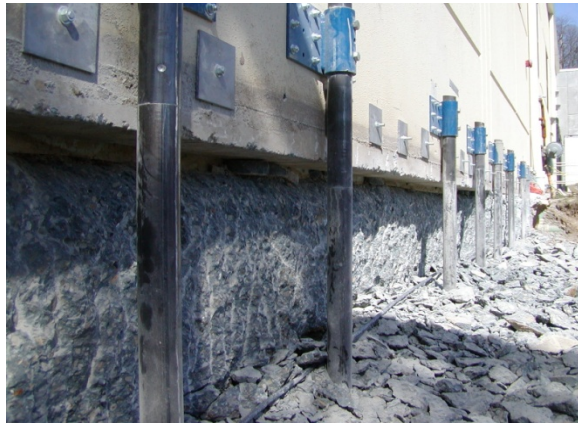
Lateral Bracing of Tilt-Up Walls using Anchor Ties into Building Slab (Courtesy of Dwyer Companies, Inc., Cincinnati, OH)

The tops of helical piles can be braced by staggering locations along walls, installing ties to hold the wall/footing from rotating and moving laterally, or by direct bracing. Sometimes a foundation wall has sufficient

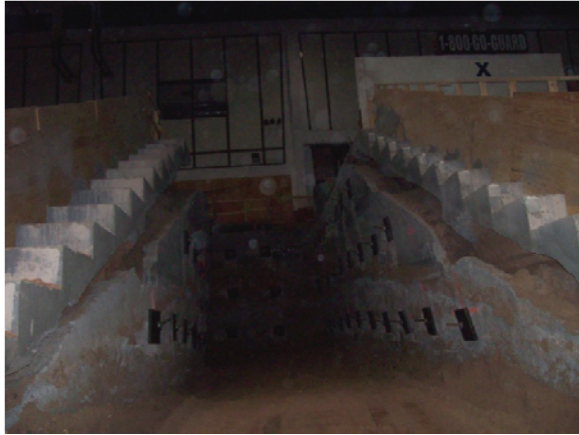
I was recently given photographs of a failed stadium project and asked to estimate the cause of failure. Three rows of helical anchors were used in a top-down excavation for a below-ground stadium renovation. The failure of the approximately 15 feet deep shoring walls reportedly occurred as a progressive “un-zipping” of the wall.

Another common failure mode of both soil nail and tie-back walls is bearing capacity failure. The weight of the facing and most importantly the downward component of thrust of all the anchors bear down on the bottom of the facing. Bearing capacity is most critical when soil nails or tie-backs are angled downward steeply. The helical anchors on the stadium project appear

to be angled between 30 and 45 degrees from horizontal. This means that between 50 and 70% of the anchor force is oriented downward. The net result is a large force dragging the facing downward. Bearing capacity failure can be resisted by installing piles at the base of the wall or simply by forming a footing with the Shotcrete. Another way to reduce downward force is to install anchors horizontally.

Failure of Stadium Shoring Walls

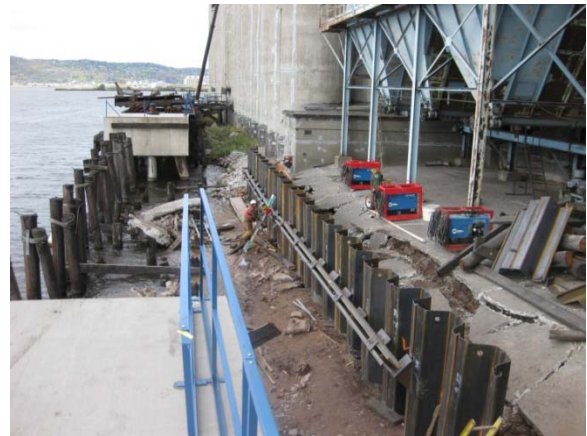
Our company was recently involved in the emergency repair of an old reticulated timber pile marine wall along Lake Superior. The repair consisted of installation of a new sheet pile wall with a single row of helical tie-backs. The 11 cm [4.5 inch] diameter shaft helical tie-backs were designed for a working load of 267 kN [60 kips]. The anchors reached torque just a few feet short of an anticipated dense layer, but were deemed admissible because of uncertainties within the ground. When it came time to proof test the tie-backs, the tests failed at about half of the anticipated capacity.

Emergency Sea Wall Repair

The inadequate proof tests on the first set of tie-backs for the sea wall were later explained by a lack of calibration. The first torque motor used on this project was supposed to generate 27 kN-m [20,000 ft-lbs] of torque. Subsequent calibration testing showed the first motor could only produce roughly 50% of the supposed maximum torque which correlated nearly exactly to the proof tests.

A supplemental set of 8 cm [3 in] diameter shaft helical tie-backs had to be installed. The second set of anchors was designed using exactly the same methods as the first set except they were designed for half the capacity with half the helical bearing plates. They were installed to roughly half the torque using a different torque motor. All of the supplemental anchors passed their proof test. What happened?

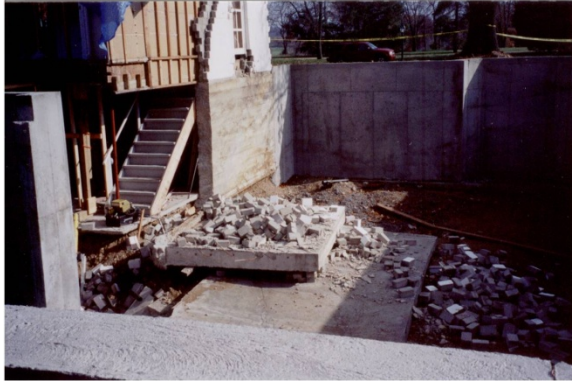
The existing home consisted of cast-in-place concrete basement walls supporting a wood frame structure with two courses of brick veneer. Penetrations had been made through the back basement wall for access to the new addition. The wall was free at both sides and held at the top only by brick ties. During installation of the first pile, the wall became unstable and tipped over. The weight of the nearly 6 ton section of basement wall instantly killed a worker.

Tragic Basement Wall Collapse due to Undermining

The cause of this accident was undermining the foundation wall. Foundation repair contractors and engineers need to be very cautious and take time to assess the stability of their surroundings. Let's hope this tragedy is never repeated.
